Science Flight Report

Operation IceBridge Arctic 2012

Flight: F03
Mission: Beaufort-Chukchi Diamond

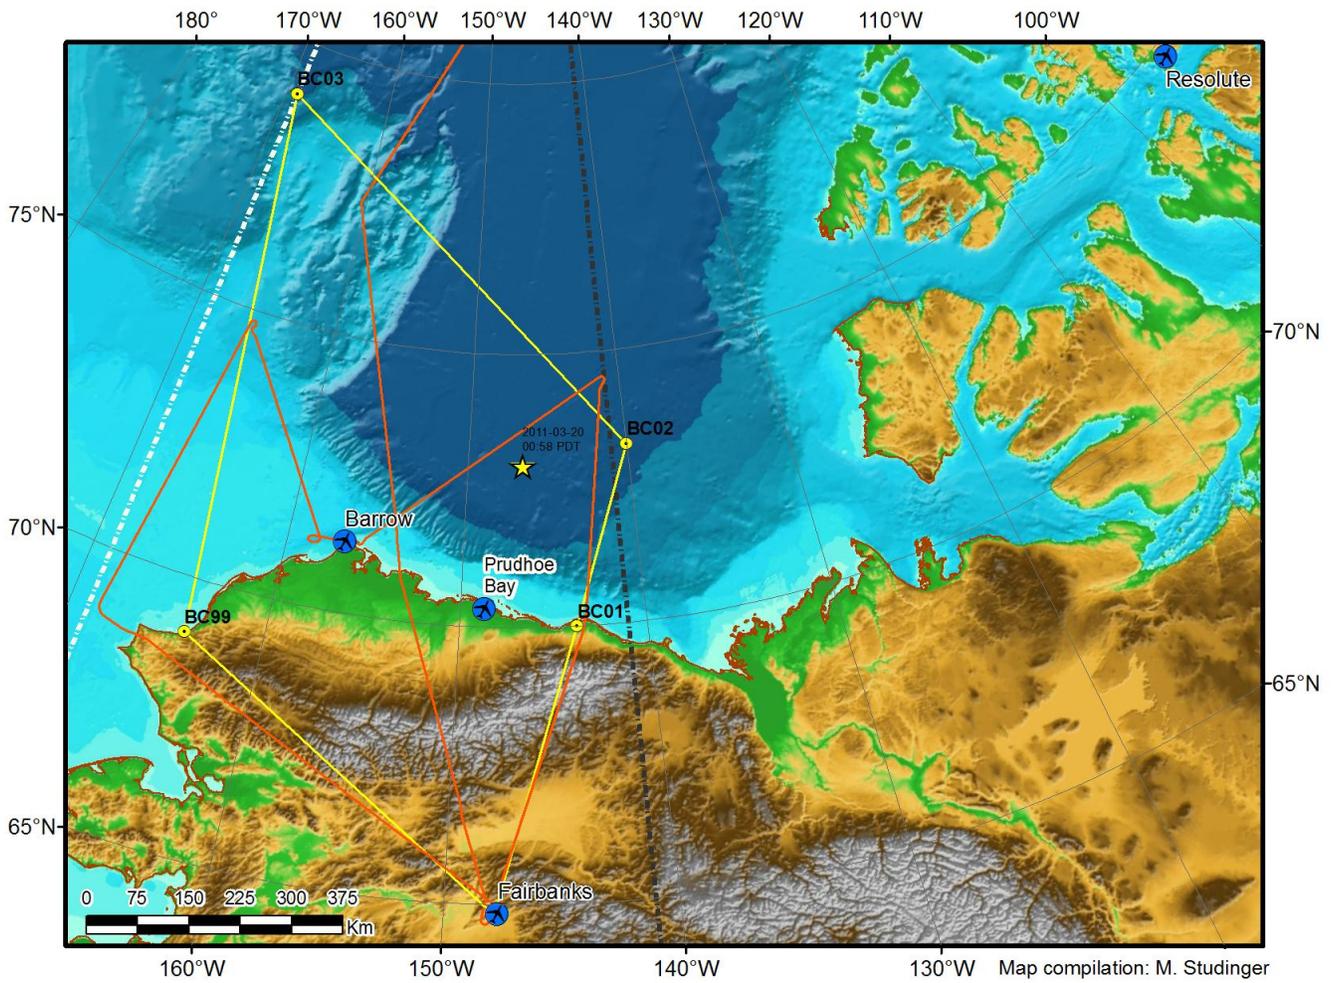
Figure 1: Today's sea ice mission plan (yellow). Star marks location of last year's ICEX2011 camp. Red lines are F01 and F02.

This is a new mission, designed to sample sea ice in the western Arctic Basin along north-south gradients in the Chukchi and Beaufort Seas. The CryoSat-2 orbit geometry was not suitable for underflights today and we therefore followed the original mission plan. The weather was perfect over the entire line as we had expected and we were able to fly the entire line at 1500 ft AGL. The location of the survey line resulted in good sun illumination allowing to us collect very good DMS imagery.

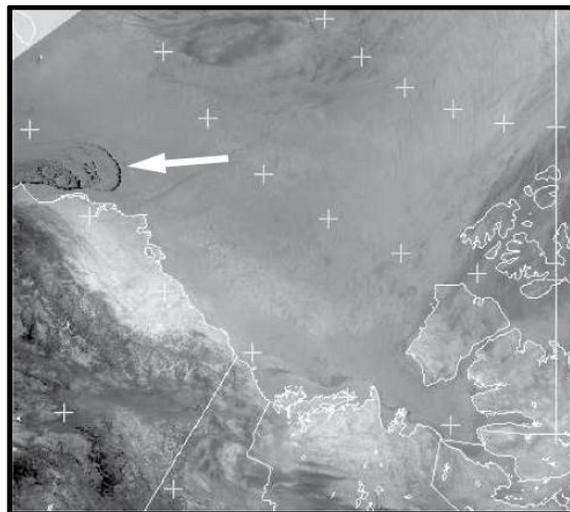
Figure 2: IR satellite image showing the large lead with open water (white arrow).

We flew over an area with open water in the Chukchi Sea that was clearly visible in the IR satellite image (see Fig. 2 and Fig. 3).

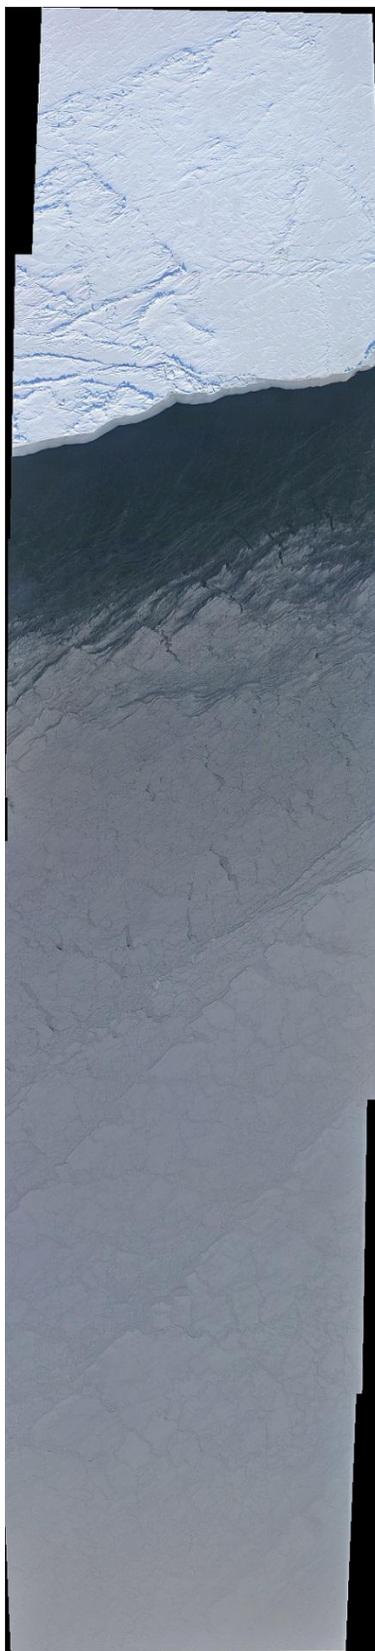
Figure 3: DMS mosaic from Eric Fraim showing the edge of the large lead that is visible in the IR satellite image in Fig. 2.

DMS: DMS worked well and collected 15,709 “fraims” (sic!). No issues on the primary camera. The backup camera continued to behave flaky.
