# Science Flight Report

## Operation IceBridge Arctic 2010

**Flight:** 02  
**Mission:** Sea Ice 05

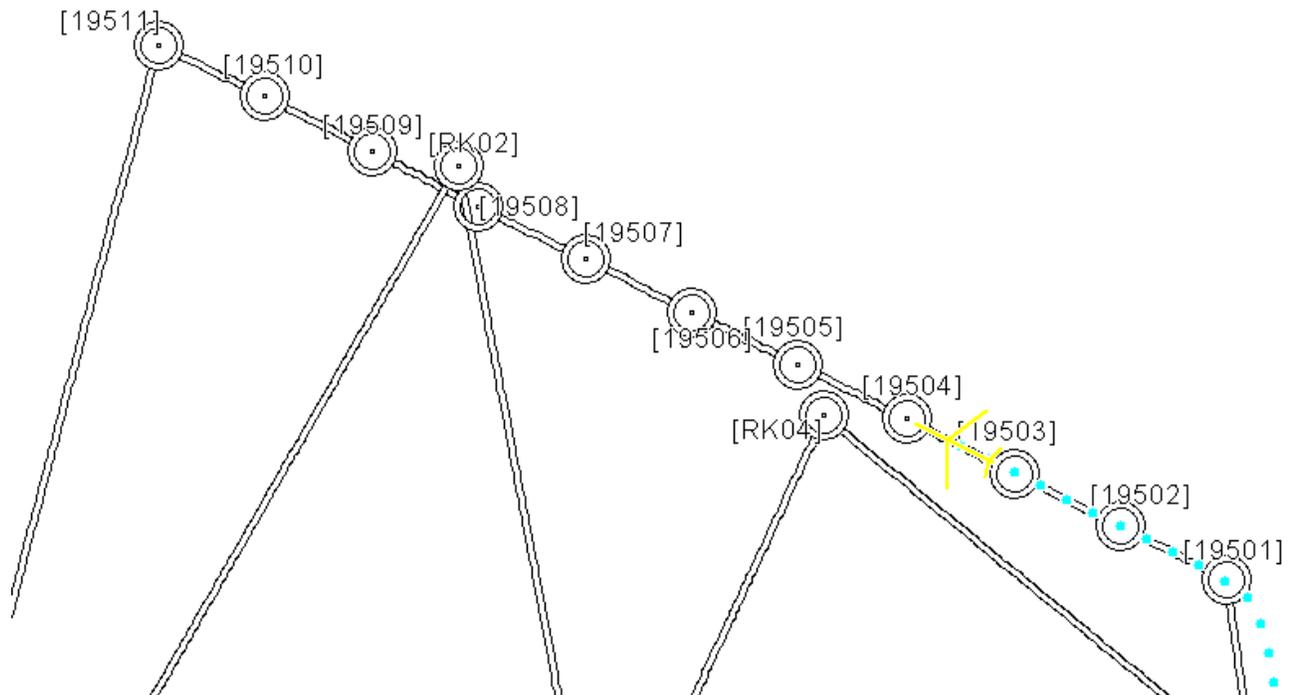
# Sea Ice 05

7.6 hours at 250 knots survey / 440 knots transit

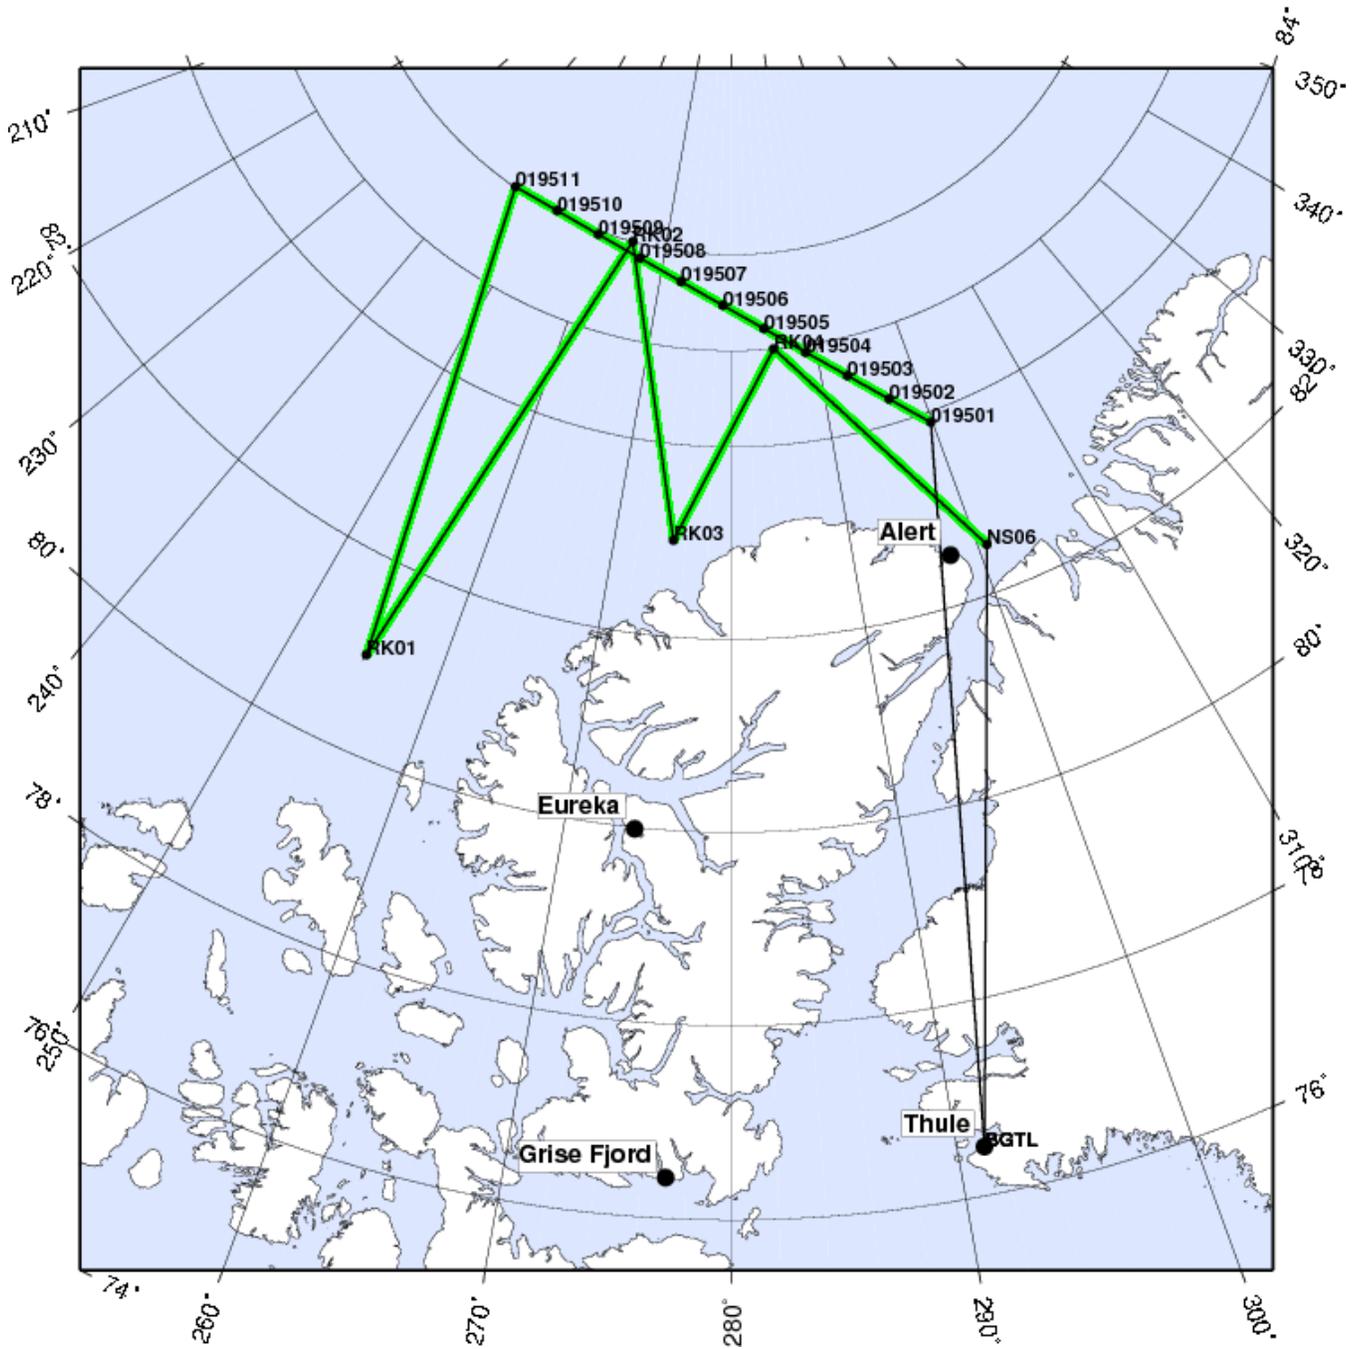
Figure 1: Waypoints and survey area of Flight 02 from John Sonntag.

Time (UTC)	Latitude	Longitude	Event
11:01:35			Takeoff
12:16:14	+83° 54.6'	-060° 28.5'	WP 19501
12:22:46	+84° 15.5'	-063° 25.4'	WP 19502
12:36:00	+84° 55.8'	-071° 21.2'	WP 19504
13:09:23	+85° 57.8'	-100° 16.6'	WP 19509
13:21:51	+86° 00.6'	-113° 39.7'	WP 19511
14:25:43	+80° 60.0'	-104° 60.0'	WP RK01
15:45:53	+85° 55.1'	-095° 21.1'	WP RK02
16:29:22	+82° 48.6'	-084° 47.0'	WP RK03
17:06:37	+84° 59.8'	-075° 01.7'	WP RK04
17:31:02	+83° 47.9'	-059° 39.7'	WP NS06
18:54:59			Landing
